WATER QUALITY MASTER PLAN

THE VILLAGE OF ARDEN, DELAWARE

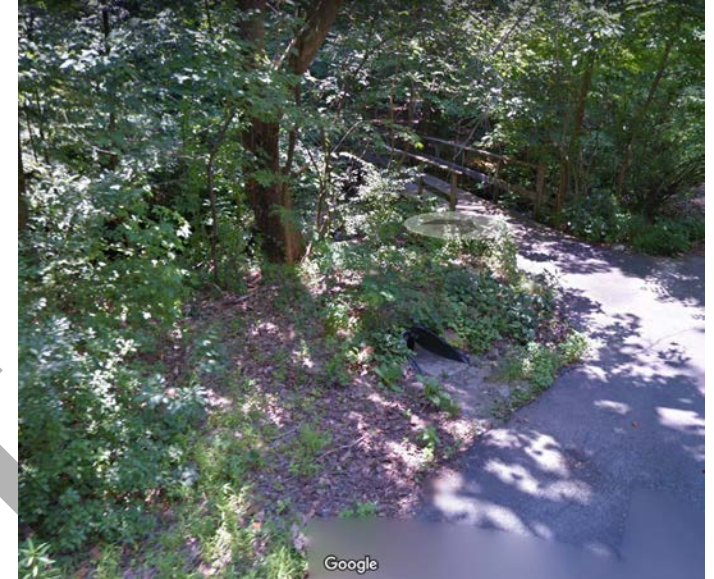
c1

This is a PVC flared end section pipe that collects water on Meadow Lane and pipes it to the creek just beyond the road. The invert showed signs of sediment deposition. This gravel and sediment will likely travel very quickly to the creek during rain events and should be cleaned regularly to avoid introducing gravel with potential roadway chemical impairments, such as oil, into the creek.

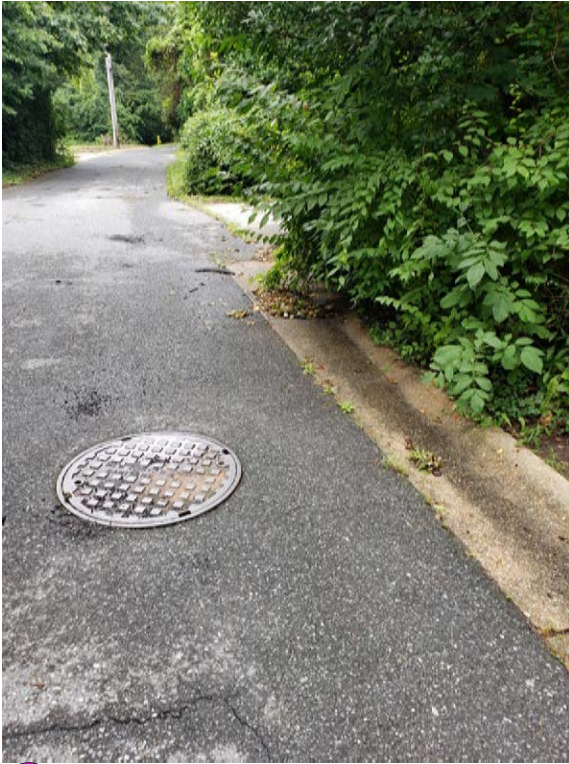
c2

This is a catch basin within a concrete gutter along Meadow Lane (under shrub branches). Debris deposition could be seen in the gutter as well as leaves over the catch basin, as visible in the image. This catch basin is connected to same pipe network as the the additional images shown for c2.

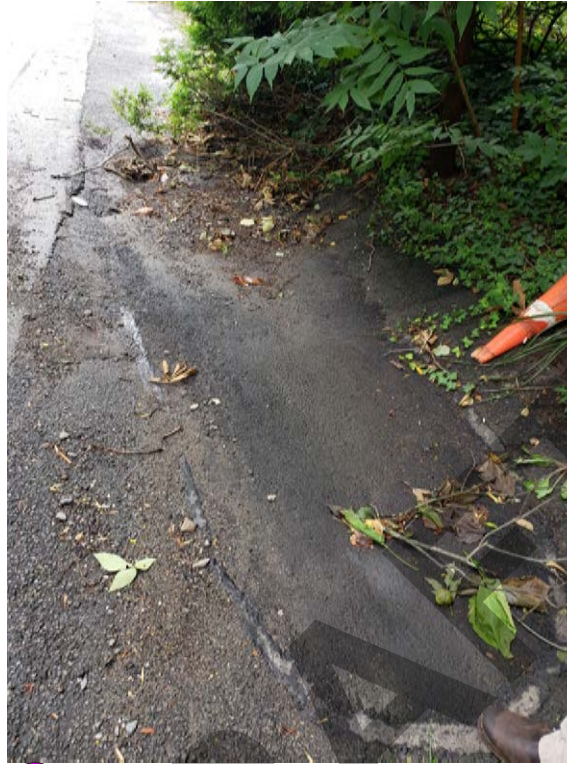
c2

There are two catch basins along the west side of Harvey Road. Both were visibly clogged with debris. These two catch basins are considered part of Harvey Road and under DeIDOTs road maintenance. However the catch basins appear to connect underground to the catch basin on Meadow Lane and ultimately discharging to the concrete flared end section to the creek. A FOIA request of the DeIDOT owned catch basins in the area is included in the appendices.

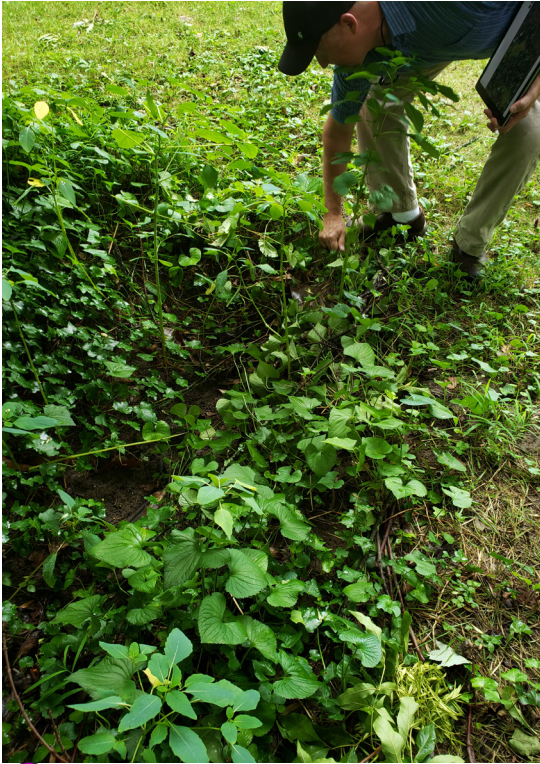
c3

There is one catch basin in the parking lot to Guild Hall. The catch basin appears to be piped underground and outfalls lower down on the slope behind the parking area. The water then appears to travel through small swales, such as that pictured, to the open area in the Memorial Garden. The network appeared stable. The corner of the parking lot opposite the catch basin did not appear stable and stormwater was eroding the corner of the lot.

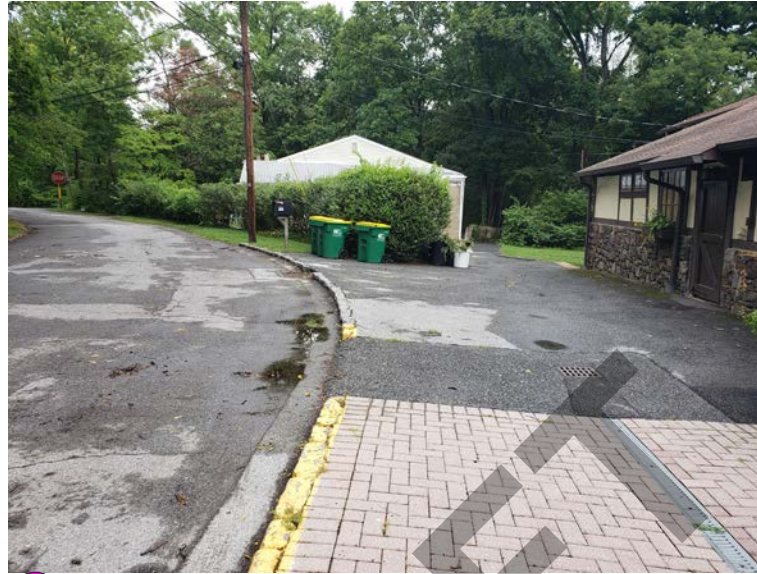
c4

There is a network of small catch basins that collect water in front of Guild Hall and the residence adjacent to Guild Hall. The outfall location was not able to be located but it is assumed likely in the hillside that drains to the open area in the Memorial Garden. The network appeared stable on the surface but ponding was visible in several locations throughout the area. It is likely some of this ponding can be mitigated through BMP implementation but to what extent the drainage network is or is not functioning properly was not able to be ascertained.

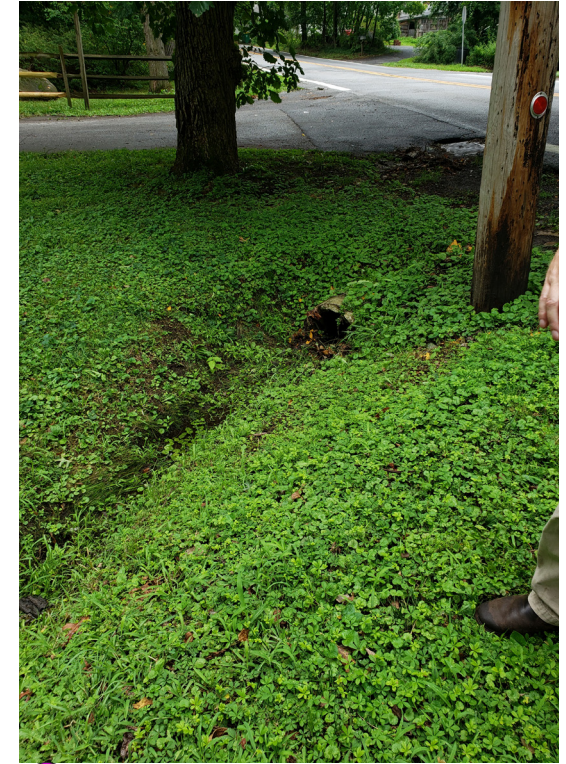
c5

There is a network of multiple catch basins along Lower Lane. The outfall location of this network was not clear. It is assumed it connects to this open area that connects underground to the system on Meadow Lane. This pipe is believed to be providing a collection point for the east side of the Memorial Garden to be directed under Harvey Road to free the intersection of ponding. The network was provided a separate number but if Lower Lane does connect at this point and joins Meadow Lane it would be part of the already taxed c2 network.

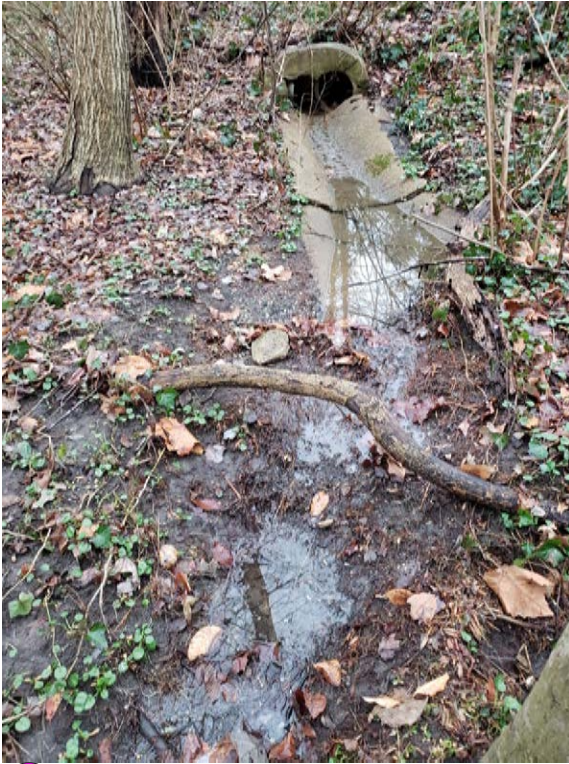
e1

There is a network of multiple catch basins along Millers Road north of Hillside Road, that run north and outfall into Arden Woods via the concrete gutter shown in the image. The outfall has created an eroded channel through the woods to the creek. The concrete gutter should be removed and natural techniques such as log sills and plantings used to stabilize the channel.

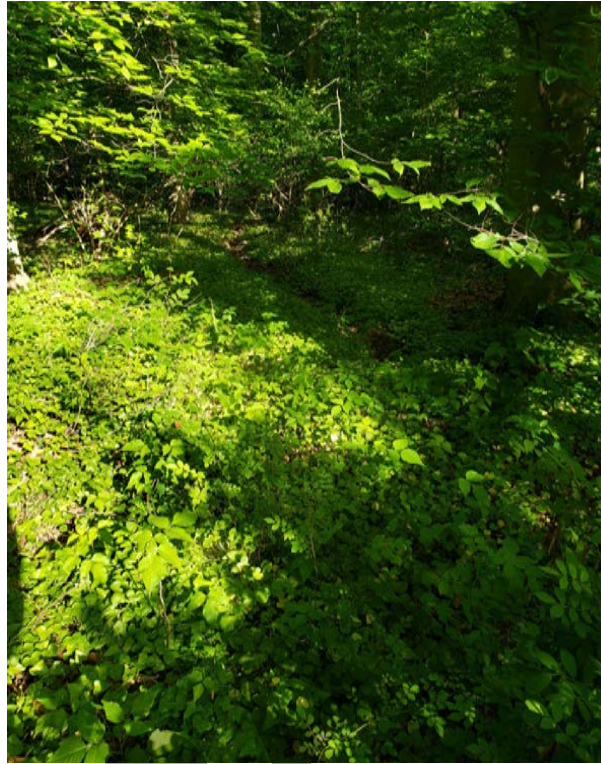
e2

The network of catch basins at the bottom of Hillside Lane appears to connect to an outfall that is just at the edge of the woods beyond the roads end. The outfall location could not be found but a small channel was visible and assumed to be the likely flow path from the catch basins to Naamans Creek. The channel did not appear significantly eroded.

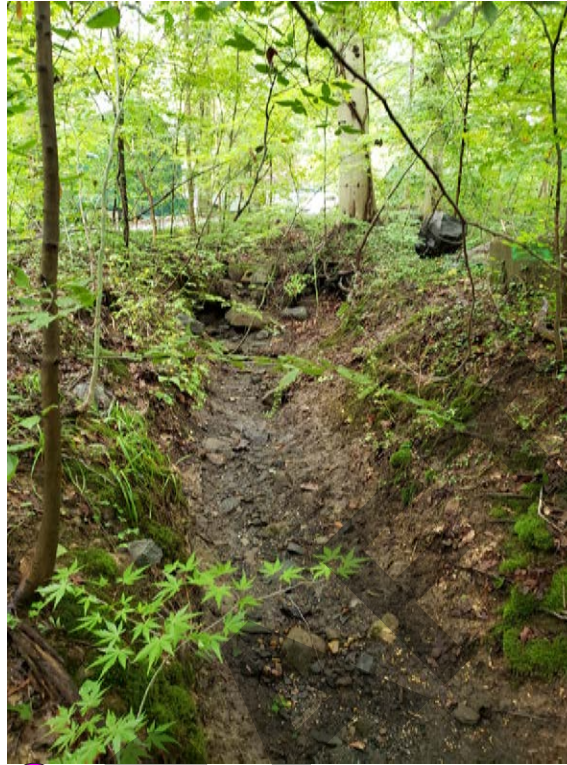
h

The network of catch basins along Woodland Lane, including the one that catches overflow from the existing rain garden, discharges to an outfall on the north side of Woodland Lane. The image above shows the channel eroded by the outfall point.

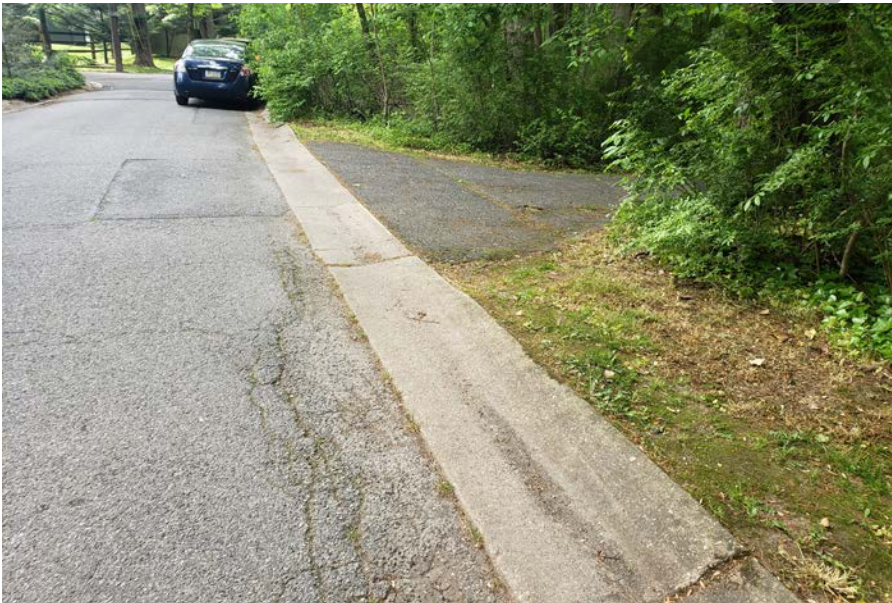
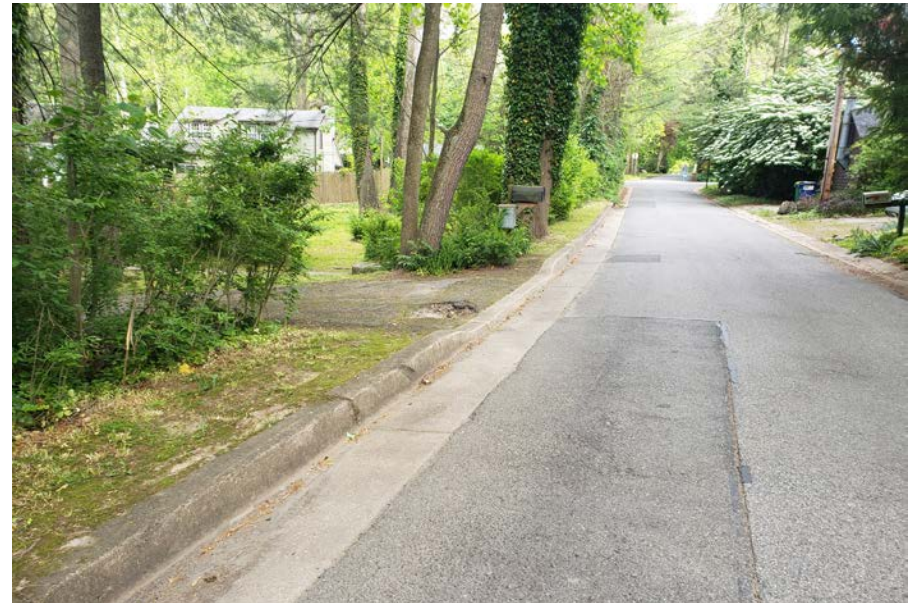
As the catch basin network along Harvey Road illustrates, maintenance is a critical component to drainage infrastructure function. Good drainage is not the focus of this plan but improper maintenance can lead to severe water quality impairments over time. With that said, good drainage can also negatively effect water quality when not properly designed for the receiving waterway. Areas like this are examples of slow drainage reducing negative impacts downstream. There are many instances where the undersizing of pipes and culverts have prevented large scale erosion by forcing water to pond and slow down before entering the more natural portions of the Arden's landscape. The primary point of this section is to inform the residents of Arden what they have and what they should look for, with the ultimate goal being a good balance between functioning drainage infrastructure and regenerative stormwater practices. Concrete gutters are used throughout much of Arden for conveyance along roadways. There are several types with the two images below being the most common. The image on the left illustrates a rolled curb and gutter, note the curving concave shape. The image on the right illustrates an upright curb and gutter system. When this system crosses a driveway it transitions from upright curb to a mountable depressed curb. Both systems work well at conveyance and the primary maintenance is to keep them clear of debris, which is easily accomplished with regular street sweeping, which is a type of BMP. Although the depressed curb may appear "higher" than the rolled curb, often the vertical distance between the low point in the gutter and the driveway is the same as a depressed curb, the soft transitions create an optical illusion. It should be noted this is often the case, but the rise in the images was not measured to confirm; there are several locations where the depressed section of curb visibly offers inadequate capacity and the taller roll curb section without the reduced height should be used. The primary problem with this system is not the system itself, but where they stop. There are several instances noted in this plan where both drainage and water quality have been effected because concrete gutters along roadways end abruptly with no directed path for the stormwater, thus it seeks the lowest gradient that can lead anywhere, including a residence. Valley gutters can also be found in the Arden drainage infrastructure. These are similar to

roadway gutters but are often used to cross a road as opposed to running parallel, like the one at the bottom of Meadow Lane. The maintenance of these would be the same, to keep them clear of debris and monitor the stability of the area where they end.

Not all catch basins work the same. The image to the right shows a traditional flat catch basin. This style is usually less costly at implementation but overtime loses function and often creates more costly fixes downstream. As illustrated in the image, they easily clog with debris and once clogged the water seeks a new flow path. The image on the bottom left is the most ideal style and as catch basins are replaced in Arden, it is recommended all basins be transitioned to this style. The grate works as a traditional flat basin but should the grate be clogged or become clogged during a heavy event, such as a large rainfall during the fall season when there are lots of leaves on the ground, the water will still be able to enter the drainage network via the open vertical area to the back of the catch basin. If there are concerns about small humans and animals getting caught, they do make vertical grates for these areas, even with a grate, the vertical rise area will continue to let water enter the network and drain properly.

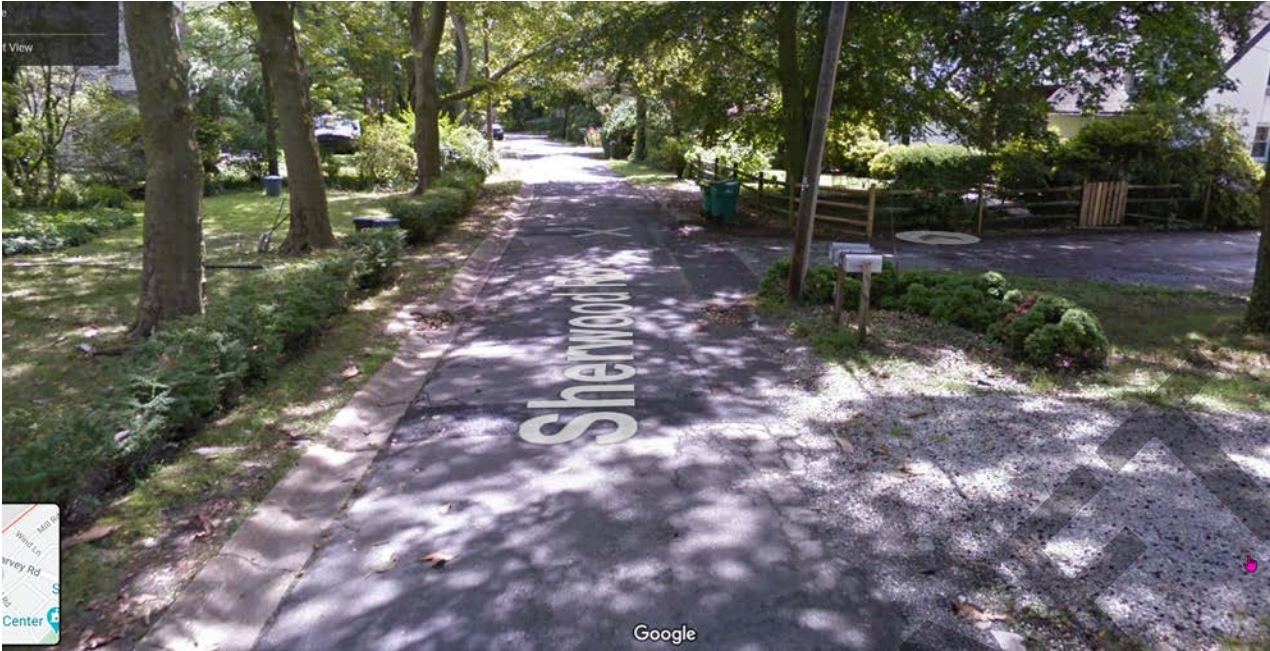
1

Sherwood Road looking south toward Hillside Road.

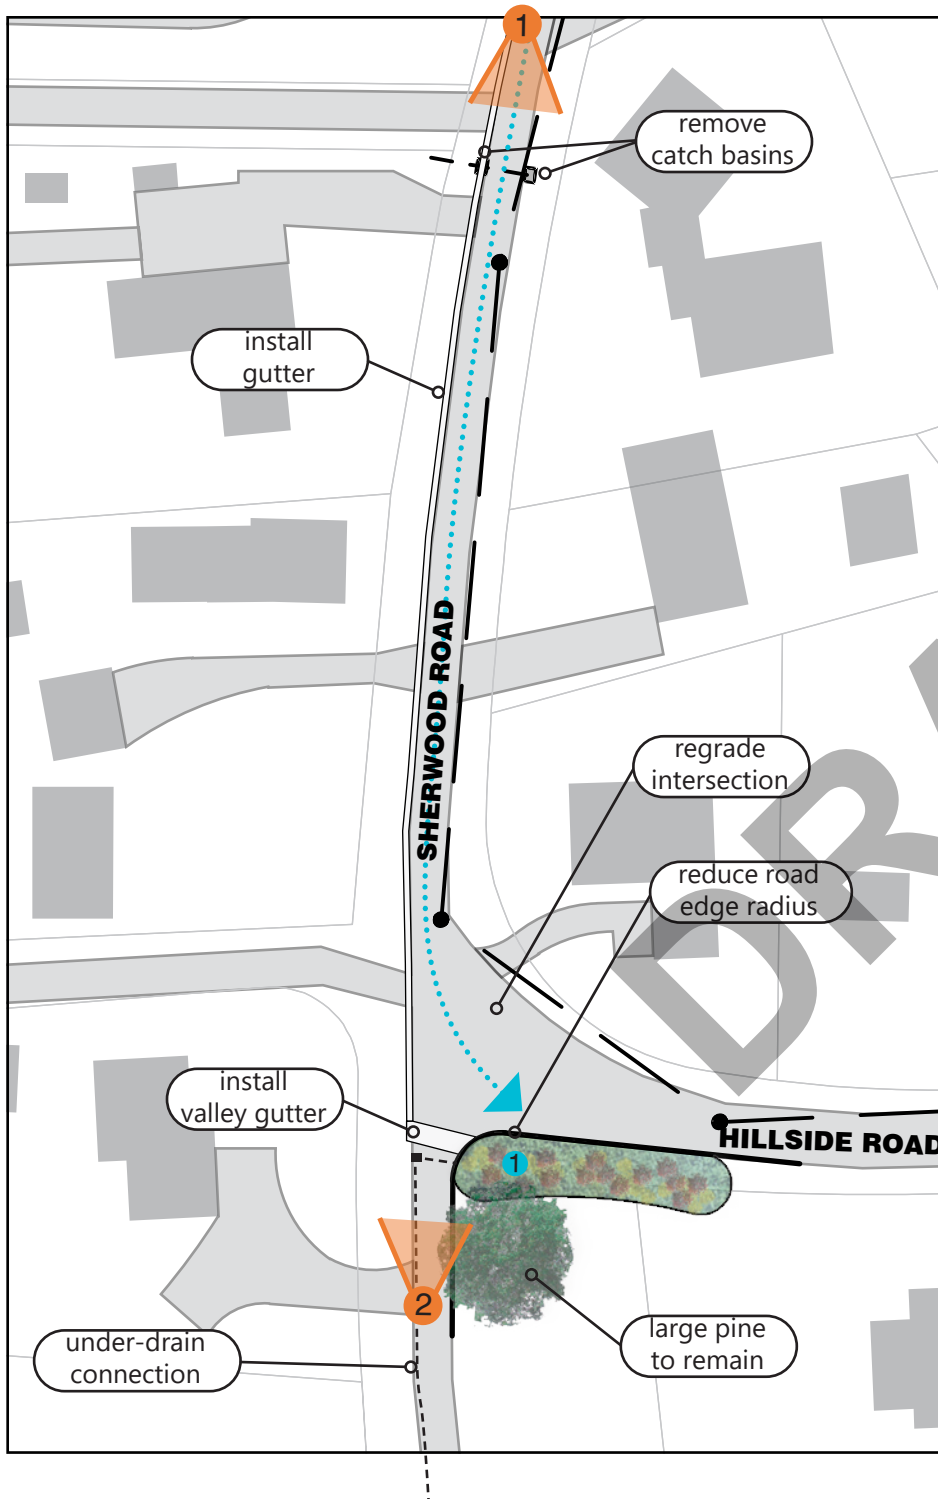
North view of Sherwood Road and Hillside Road intersection.

The wet soils and crackling pavement imply stormwater may not drain well from the roadway in this area. Site observations suggest when road runoff gets to this intersection there is no defined drainage path. Factors likely contributing to the lack of defined drainage include a slight curb on the north side of the island creates a dam effect where water likely puddles, and on the east side of the road the concrete gutter ends prior to the intersection leaving an undefined flowpath for upslope road runoff.

To assist in treating water quality and reducing storm surge downstream, it is suggested a bio-retention garden be installed in an area of paving removal. The proposed system suggests removing the catch basins and speed bump to ensure road run-off reaches the garden, installing a concrete road gutter on the west side of the road to direct drainage to this location, repairing the east side gutter as needed, and installing a concrete valley gutter to direct water across the road and into the garden. It is recommended the intersection have a reduced radius on the south side and the existing island be paved, to provide area for the BMP and vehicle maneuvers. The entire intersection from the end of Watershed A should be re-graded to slope to the garden, as illustrated with the dotted blue line arrow. Given the lack of sewer infrastructure and the existing downstream catch basin network, it is likely feasible to connect the bio-retention garden's under-drain and overflow system to the existing storm drain network at the intersection of Lover's Lane. The large pine is assumed to have more of its root structure growing towards the open grass areas and not toward the existing road. It is anticipated in this plan to remain; it is strongly suggested a certified arborist be contacted as required to protect the tree during construction.

The drainage area for the garden is ~49,685 sf. The impervious area within this drainage area is ~20,859 sf. (42%). A garden footprint as shown for A1 at 2.5 ft deep would support a storage volume of ~1,650 cu. ft. This size would capture the water quality event of 2". Estimated costs for the facility would be \$87,750*.

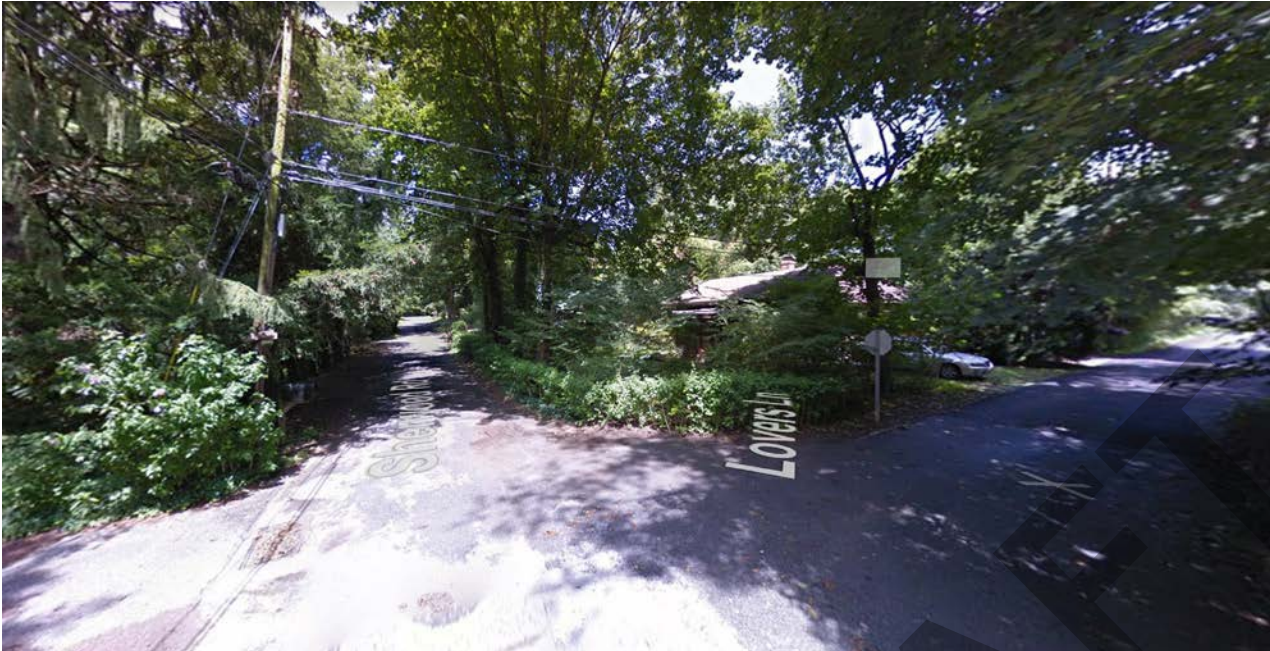
1

North view of Sherwood Road and Lovers Lane intersection.

The image to the left shows the northeast intersection where the implementation of a bio-retention garden is suggested. There is a visible sewer manhole at the center of the intersection but the existing catch basins suggest introducing a water quality facility is feasible. Depending on where the boundary is between leaseholder land and common land, the visible hedgerow may need adjustments.

To assist in treating water quality, it is suggested a bio-retention garden and a bio-swale be installed to treat unmanaged stormwater from Sherwood Road. The bio-retention garden should be installed within the common lands at the intersection of Lovers Lane. Concrete gutters should be installed to each side of the road to direct water to the garden. The west side gutter will need a valley gutter or trench drain to cross over Sherwood Road to direct the stormwater into the proposed garden. The existing catch basin should be modified to meet overflow and under-drain requirements as needed. After the bio-retention garden the concrete gutters should continue to direct water to the Sunset Road intersection. The gutters should run adjacent to the existing speed bump and a valley gutter installed across Sherwood Road to direct the water from the gutters to the swale. The intersection should be re-graded to direct water from both roads to flow into the common lands of the Buzz Ware. The curb along the Buzz Ware open lands should be removed to encourage water into the open space and bio-swale. At the feasibility level there is no identifiable outlet location for the bio-swale, Watershed C BMP 4 suggests a possible connection but it is limited in its analysis. Future construction level investigations will be needed to determine the opportunity to implement a bio-swale with the visible constraints in the form of trees, rocks, and utilities, as well as safe conveyance at the end of the swale.

The drainage area for the garden is ~36,775 sf. The impervious area within this drainage area is ~7,400 sf. (20.1%). A garden footprint as shown for B1 at 2ft deep would support a storage volume of ~315 cu. ft. This size would capture the water quality event of 2". Estimated costs for the facility would be \$20,000*.

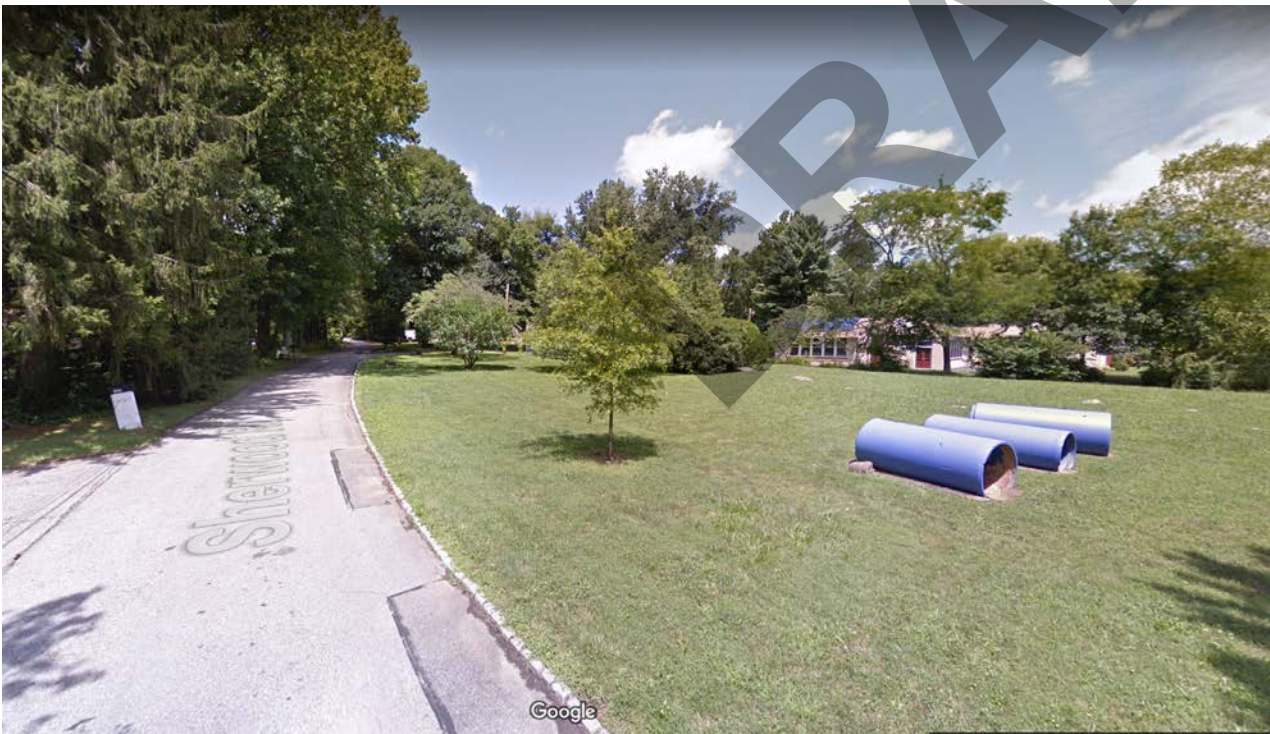
2

Sherwood Road looking north toward Sunset Road.

The image to the left shows the granite block curbing along the Buzz Ware side of Sherwood Rd. The topography along with dirt and debris collecting at the curb line suggests channelized flow along the curb line. Removing the curb would encourage pollutants and sediment to dissipate into open space, rather than being transported downstream. The introduction of a bio-swale / vegetative swale would increase the water quality treatment of Sherwood Road.

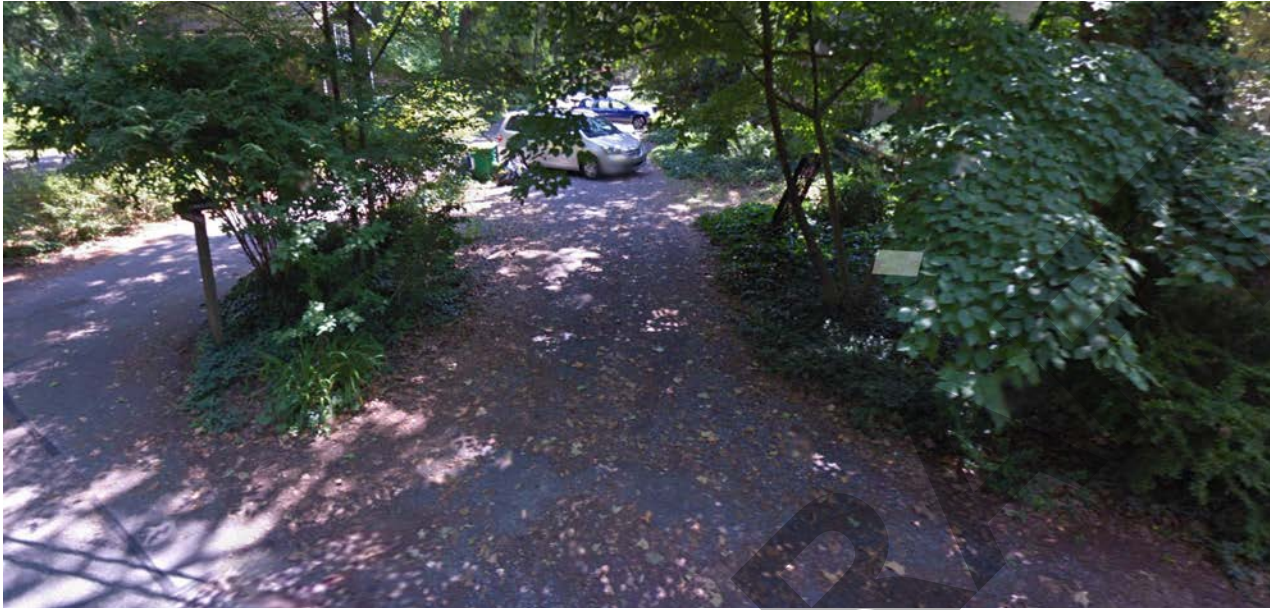
Hillside Road looking south at the intersection of Orleans Road, which is shown on the left side of the image.

This corner leasehold has a large percent of impervious coverage and the parking areas appear they could function with less of a footprint if designed in a courtyard style. Making the parking area off Orleans Road more efficient could transition this area to be used for a BMP 1.

BMP 1 - # 2118 Hillside Road appears to be roughly 38% impervious coverage with a dwelling, garage, and several loosely structured parking areas. It is suggested the upper parking area be removed and transitioned to a bio-retention garden. Internet imagery suggests that a re-design of the parking area along Orleans Road could create a more efficient “courtyard” style driveway and a more efficient layout could create additional area that would make up for the space removed for the proposed stormwater feature. With limited drainage infrastructure in the area, safe overflow conveyance would need further evaluation. An intervention in this area could treat some or most of the area highlighted in blue above BMP 1, an impervious area of approximately 0.23 acres, reducing overall effective impervious cover to 23.5%

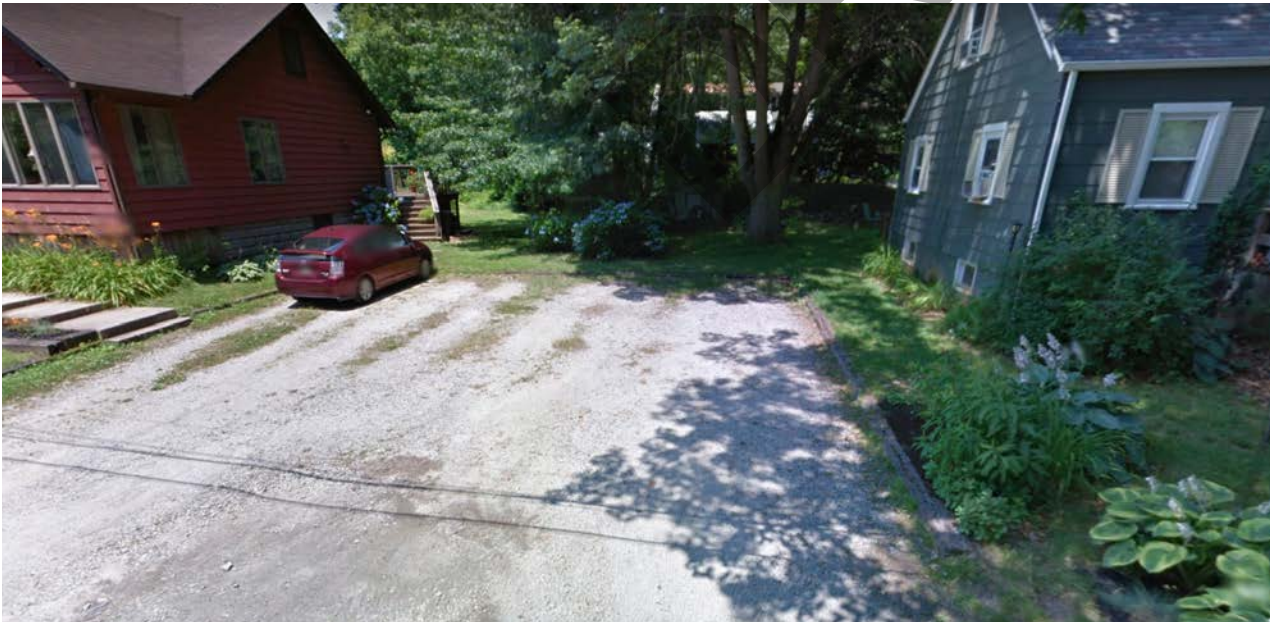
Lovers Lane looking north.

Many stone driveways exist in Arden and contribute to sediment loading as small particles wash away with storms and general wearing from vehicular traffic. This driveway has a mild slope and would be a good location to convert to porous materials for BMP 2. As costs permit a storage reservoir could be incorporated below to increase run off reduction to downstream areas.

BMP 2 - This BMP proposes to transition the parking area between 2117 and 2119 Lovers Lane to porous paving. The watershed to this parking area is small but it appears to capture enough impervious coverage to provide water quality benefits. The change from gravel to porous paving will also assist in reducing the transport of loose driveway gravel material during rain events, reducing sediment deposition into the downstream watersheds. For an added water quality benefit, this location could also utilize a cistern underneath the paving to capture more water. An intervention in this area could treat some or most of the area highlighted in pink above BMP 2, an impervious area of approximately 0.09 acres, reducing overall effective impervious cover to 23.9%

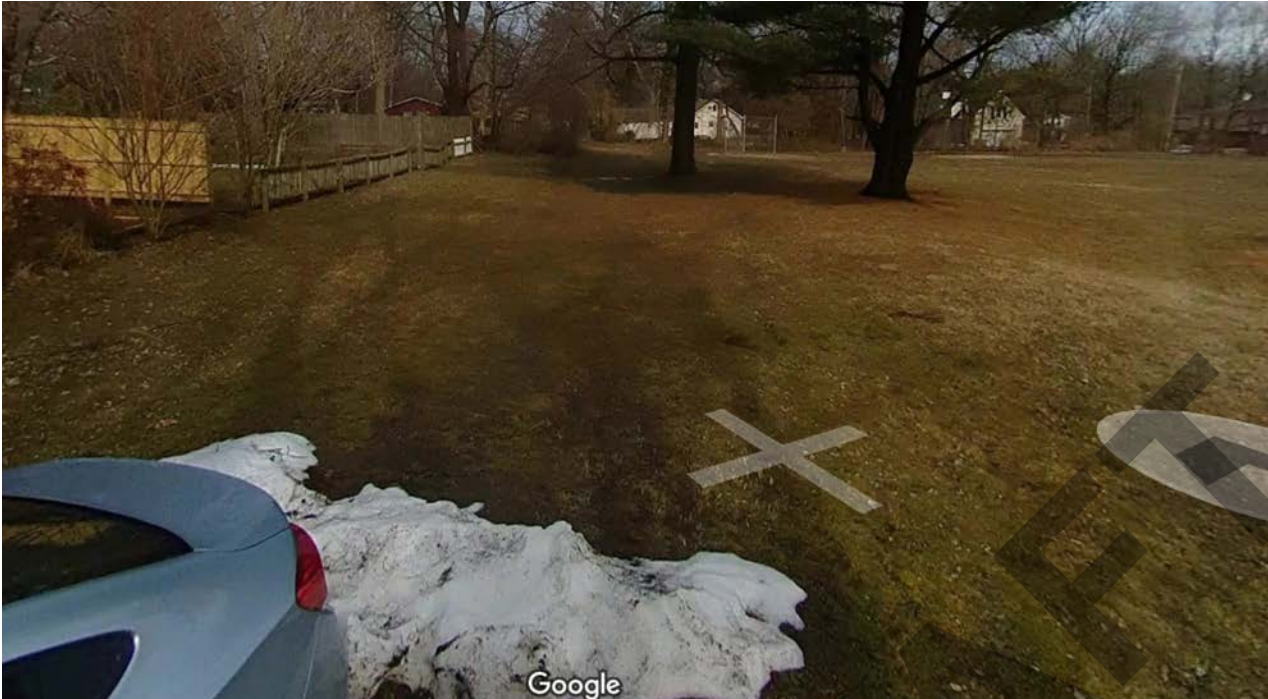
3

End of Sunset Road looking northeast toward Orleans Road

Working around existing trees, this area provides open space to implement a bio-retention garden to capture upslope drainage for BMP 3.

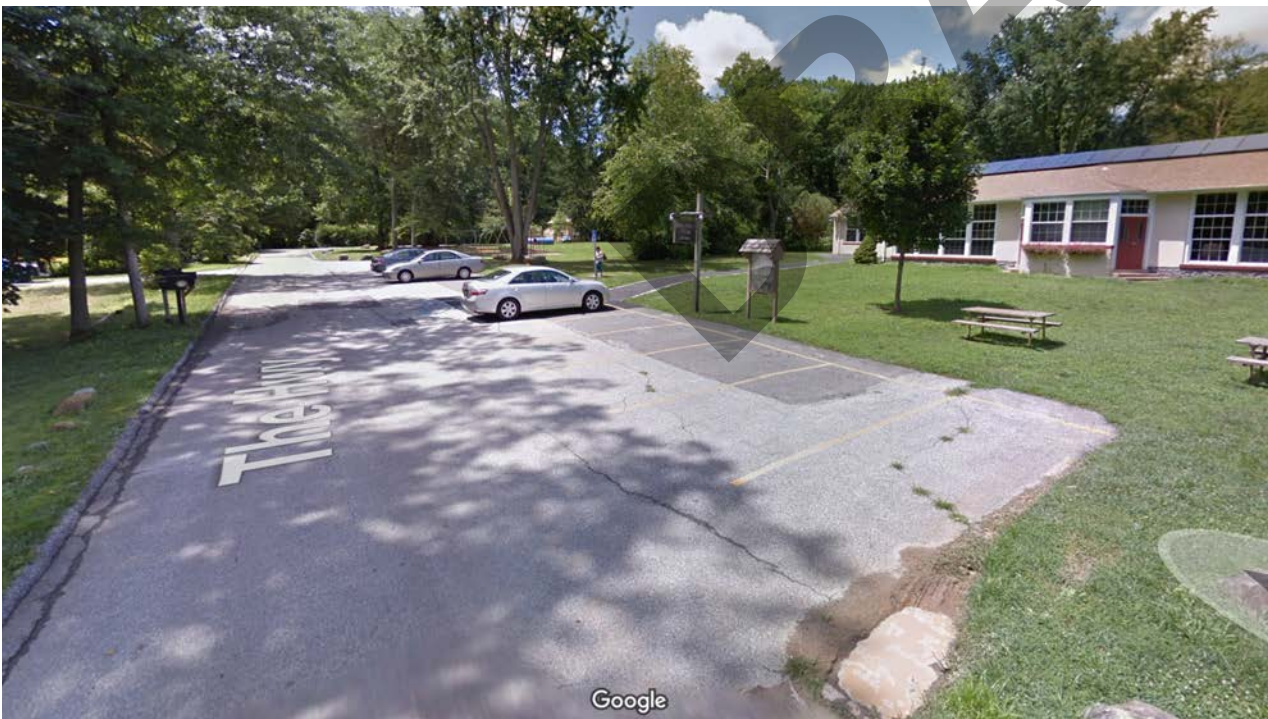
The Highway looking at the Buzz Ware parking area.

Transitioning this lot to porous material for BMP 4, can aid in reducing the runoff to downstream properties and headed southwest to Perkins Run.

BMP 4 - Two BMPs in this area are proposed; one, to transition the parking area for the Buzz Ware to porous paving and the second to add a bio-retention garden in the open space at the front of the Buzz Ware parcel. The bio-retention garden will capture the majority of impervious runoff from the sports court. This bio-retention garden will also capture run-off from the Buzz Ware building but it is suggested additional BMPs such as rain barrels be added to the building as an example of best management practices for Arden residents to emulate. Although not directly connected to this area, the design also suggests a bio-retention garden to the west of the Buzz Ware parking lot. The feasibility and hydrologic connections between the Buzz Ware parking lot and Watershed B’s bioswale should be evaluated during the construction design process. The two interventions in this area could treat some or most of the area

BMP 4 - This BMP proposes two facilities on common land which are combined into one narrative as it is assumed they have the potential to connect as needed to maximize the capture opportunities, and for safe overflow conveyance to the catch basin system along the Highway. This plan suggests implementing a bio-retention garden in the open space south of the Buzz Ware and replacement of the existing parking area for the Buzz Ware to porous paving. In the area of the proposed garden the existing trees appear in poor quality or of non-native origin; it is suggested these trees be removed. It is recommended that the design of the new facility integrate new native trees into the adjacent areas. These two facilities will capture the large impervious area generated by the Buzz Ware building, sports courts north of the building, and parking area for the Buzz Ware. Not included in this analysis, but illustrated on the map, is a second bio-retention garden to the west of the porous paving. There appears to be a low point that might aid in capturing the bio-swale from Watershed B and connecting it to this watershed's treatment suggestions. This could provide a safe outfall conveyance for the Watershed B bio-swale. Similar to the bio-swale, the area has visible bedrock and mature tree constraints and thus is being left as a suggestion for further analysis and not included as a design intervention in this plan. The BMPs in this location are the last downslope opportunity on common land to capture water within the western portion of this watershed, any opportunities to treat for both water quality and quantity should be evaluated. The drainage area for these BMPs is ~114,800 sf. The impervious area within this drainage area is ~24,675 (21.5%). A garden footprint as shown at 2ft deep would support a storage volume of ~1,760 cu. ft.; a paving footprint similar to existing at 1ft deep would support a storage volume of 1,000 cu. ft.. These sizes would capture the water quality event of 2" Estimated costs for the eastern bio-retention facility only would be \$93,500; the porous paving parking area would be \$61,550 for a combined total of \$155,050*.

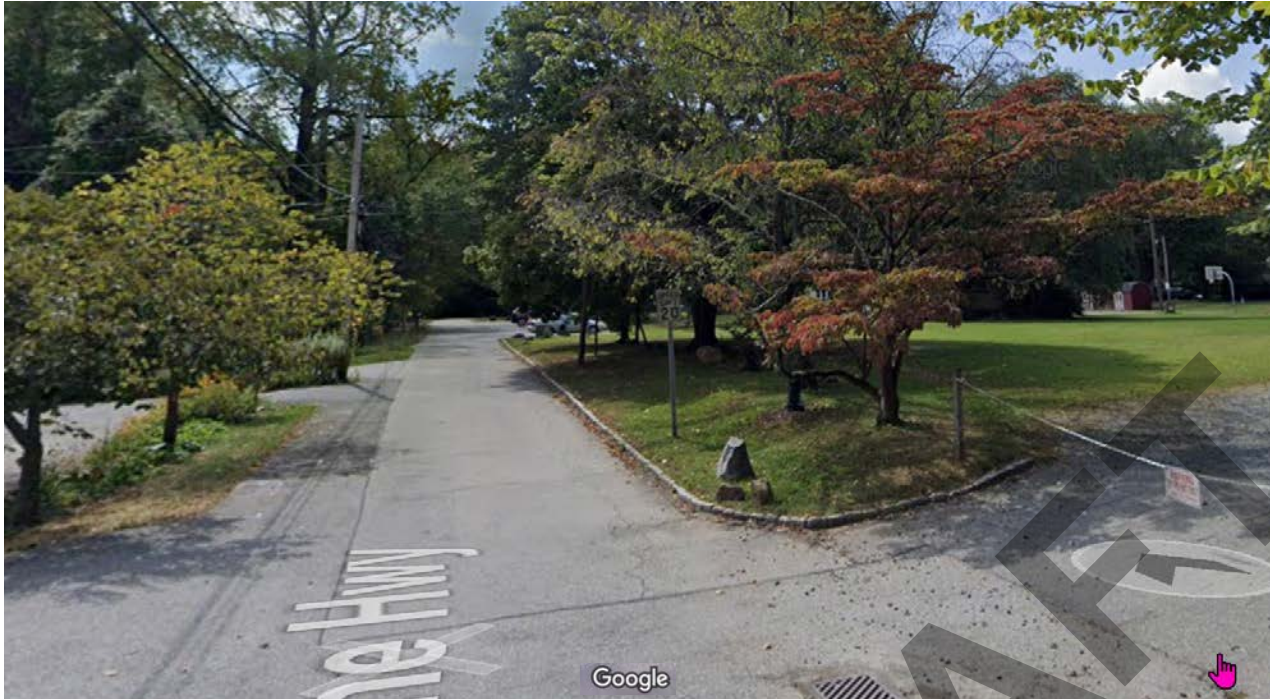
5

The Highway looking southeast toward the Buzz Ware.

The trees in this location appear to be either declining or non-native species. For BMP 4, it is suggested to remove them, install a bio-retention garden to capture run-off from the Buzz Ware and the associated sports courts / fields. New native trees can be incorporated into the design.

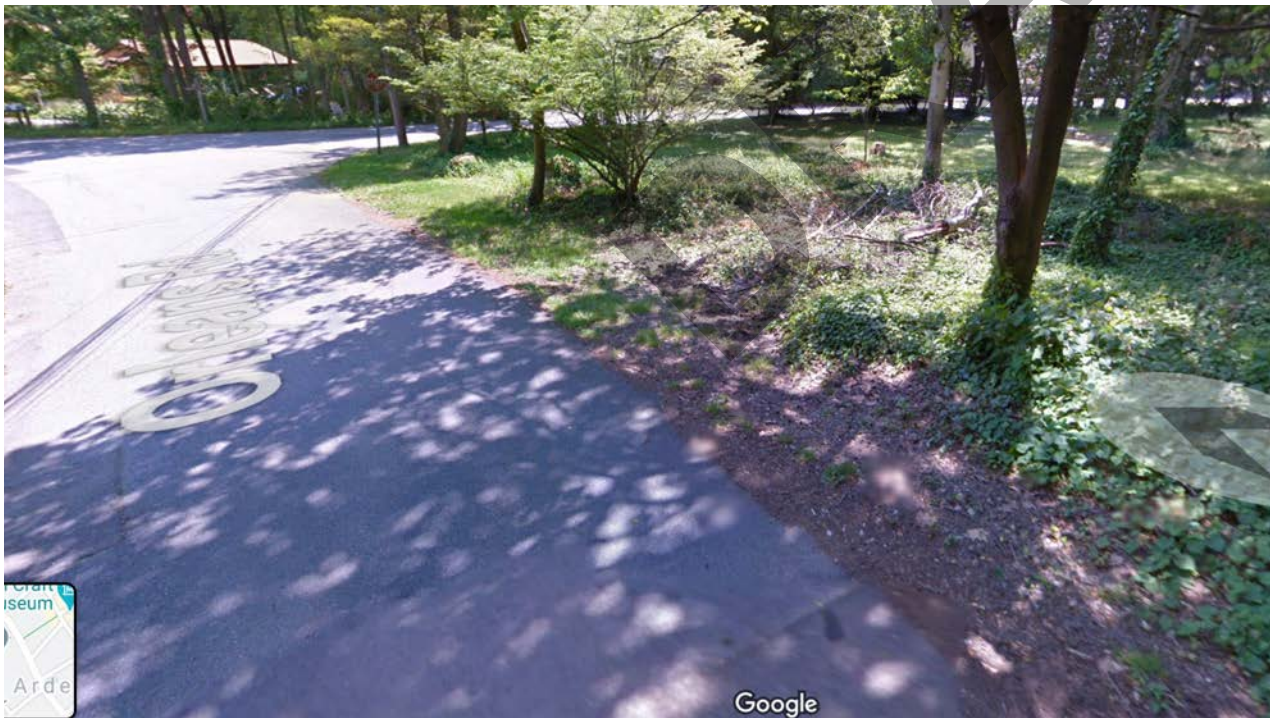
6

Orleans Road looking east, The Highway is the road in the background.

Utilizing the open space to the right of the image for BMP 5, would provide an area to treat the majority of impervious cover of Orleans Road.

BMP 5 - The boundary between Arden and leaseholder land is unclear for 2123 The Highway. For the purposes of this plan it is assumed within Arden open space. The location is ideal for a detention or bio-retention garden to reduce stormwater flows originating down Orleans Road and settling in front of Gild Hall where it is drained by a road catch basin. The majority of run-off from Orleans Road turns at this intersection and drains down to The Highway, a BMP here would treat a considerable amount of untreated impervious surface within the watershed. An intervention in this area could treat some or most of the area highlighted in blue above BMP 5, an impervious area of approximately 0.65 acres, reducing overall effective impervious cover to 22.4%

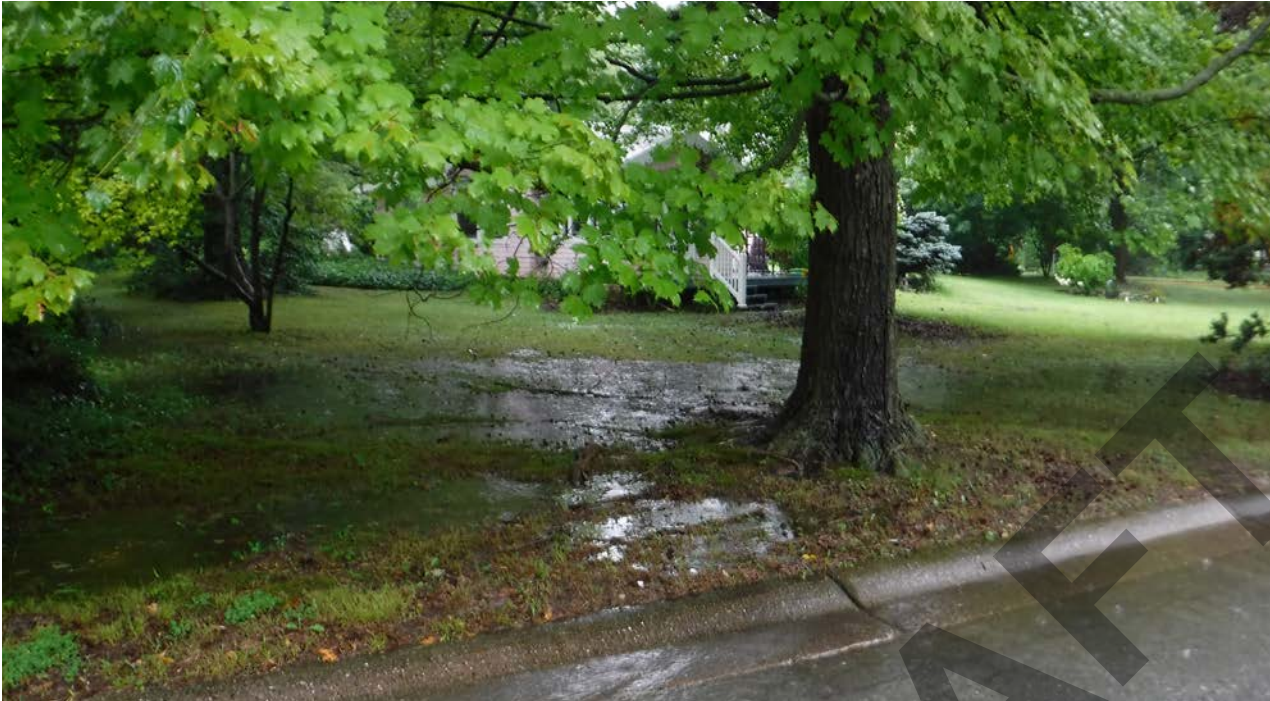
7

Orleans Road looking north at the Doll House leasehold.

This picture was taken shortly after tropical storm Isaias came through the area. BMP 6 could be implemented within the areas that are already topographical low points in the lawn.

comprised of leaseholder impervious with no roads or common lands that contribute to it. This plan strongly suggests the homes in this watershed implement leaseholder scale opportunities as noted in section 4.1. The drainage area for the garden is ~116,700 sf. The impervious area within this drainage area is ~28,900 (24.7%). A garden footprint as shown at 2ft deep would support a storage volume of ~615 cu. ft. This size would capture the water quality event of 2". Estimated costs for the facility would be \$32,700*.

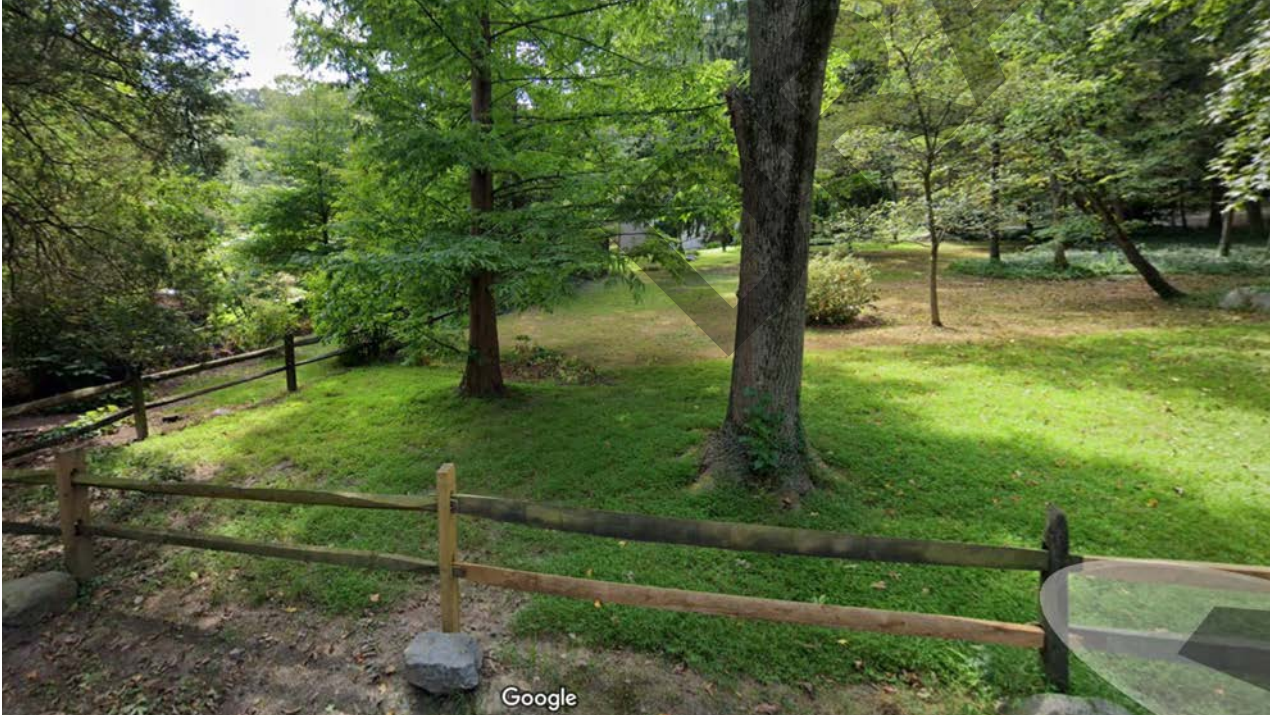
8

Pond Road facing west looking at the southern edge of 1806 Pond Road.

With care taken to reduce impacts to the existing trees, BMP 7 could be constructed in the open lawn area near the fence. In this picture that area appears brown in color.

BMP 7 - This facility is being proposed on leaseholder land. This plan suggests implementing a bio-retention garden in the area of the lawn on the side of the fence just north of the southern leasehold boundary line. The majority of trees should remain and the facility should be constructed to a size that minimizes damage to existing tree roots. During a site visit the downstream leaseholder had shown the authors a drainage network they had installed of small catch basins to move water around their dwelling. They expressed no flooding to the home but given storm events are projected to increase in intensity and volume with climate change, this facility will likely aid in reducing future flooding. The drainage area for the garden is ~49,700 sf. The impervious area within this drainage area is ~9,600 (19.3%). A garden footprint as shown at 2ft deep would support a storage volume of ~1,870 cu. ft. This size would capture the water quality event of 2". Estimated costs for the facility would be \$99,400*.
